Manhole Inspection Summary

Manhole # S27C__005MH

Location Address: **951 SARAH ANN ST**

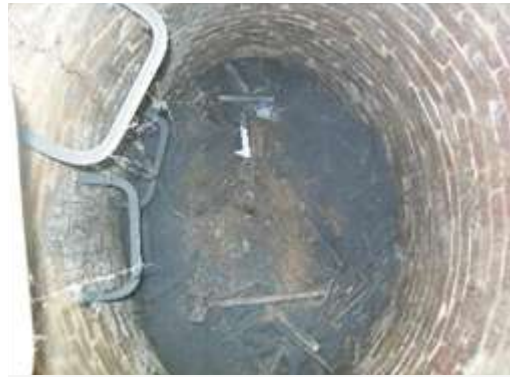
Top View

Condition: ☐ Sound ☐ Cracked ☐ Root Intrusion ☐ Deteriorated ☐ Leaks ☒ **Debris**

DEBRIS IN CHANNEL

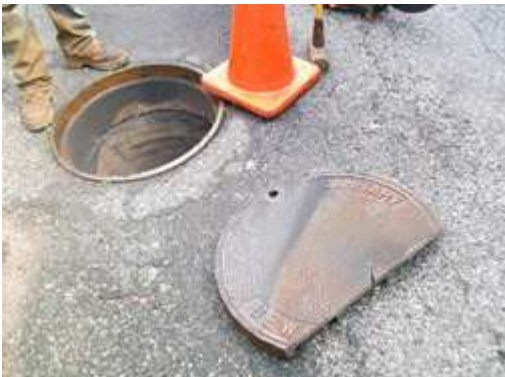
CUT OPEN STUCK COVER WITH SAW

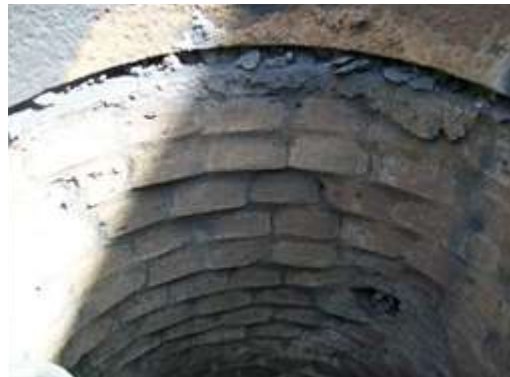
Defect 2

PIPE INTRUSION IN CORBEL WALL -
ABANDONED FRESH WATER
CLEANOUT

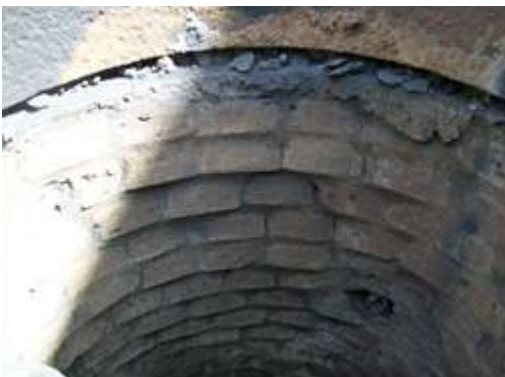
Defect 1

Condition: ☐ Sound ☐ Cracked ☐ Root Intrusion ☒ **Loose Brick** ☒ **Deteriorated**

CHIMNEY HAS LOOSE AND MISSING
BRICKS/MORTAR - DETERIORATED

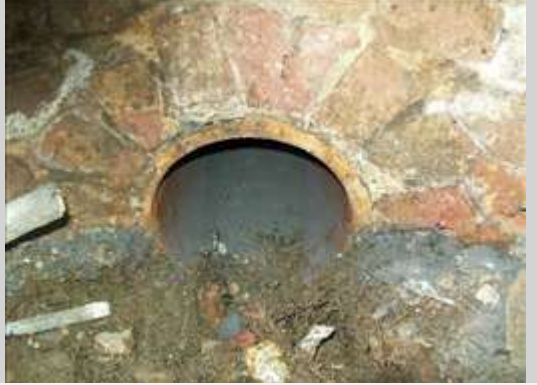
12 O'Clock Outflow

8 in. Circular Gravity Sewer
Pipe Out @ 12 O'Clock

Pipe Material: **Clay** ☐ Pipe Lined

Invert Depth: **7.83** (ft.) Flow Characteristics: **None**

Infiltration: **None** Pipe Seal Cond: **Sound**
